Friends of Island View Beach

Response to the CRD 2016 draft
proposal

Island View Beach Regional Park

July 8, 2016

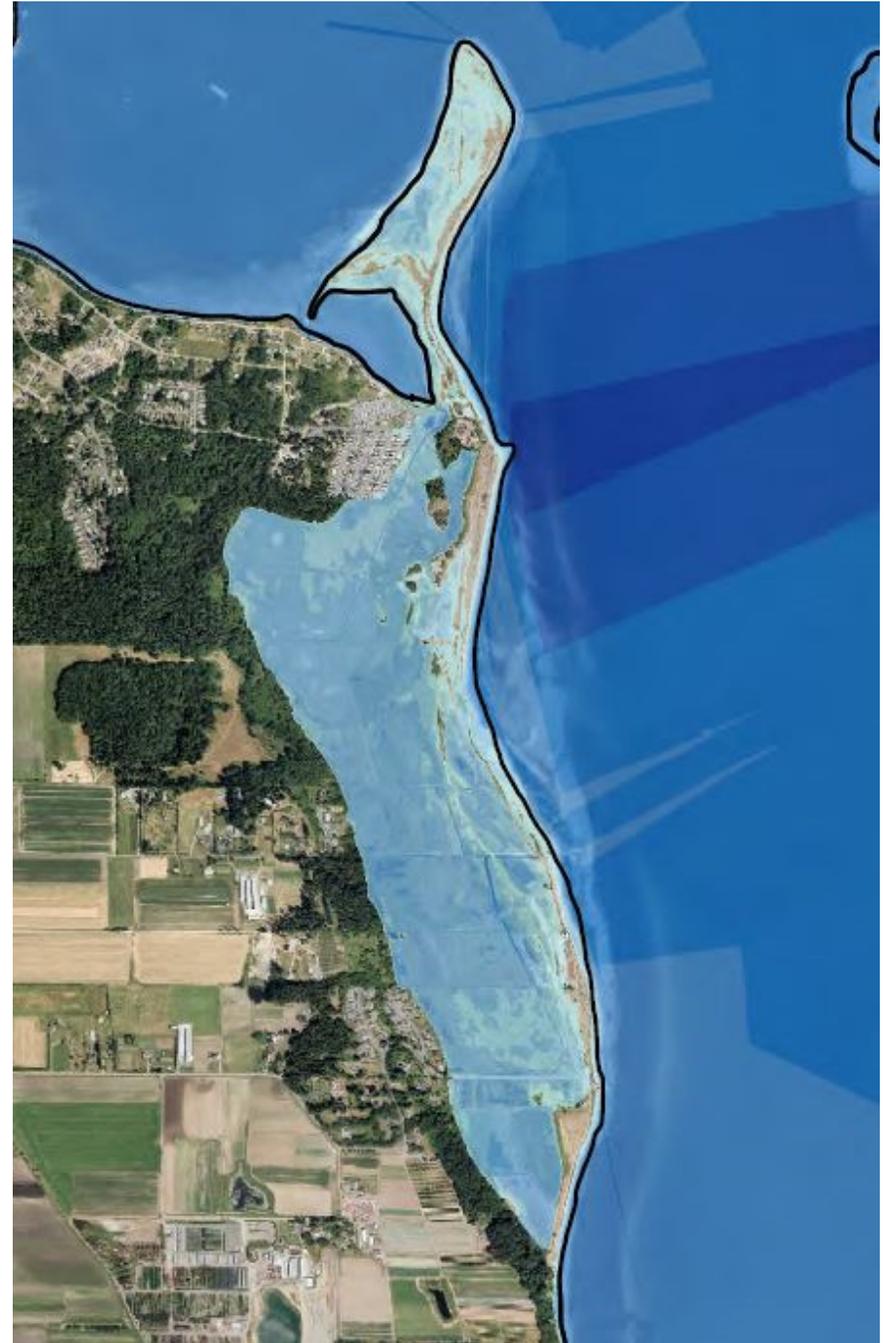
This is a CRD map showing that Island View Beach will be inundated with just a **0.5m** rise in sea level

A CRD report said a **0.5m** sea level rise will inundate Island View Beach.

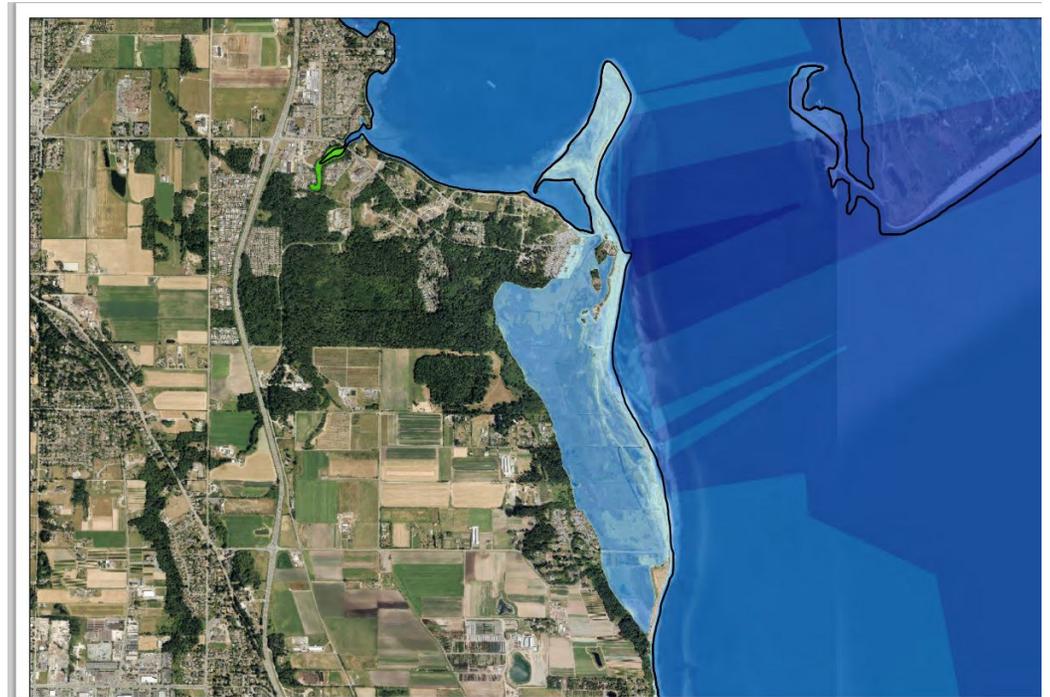
This CRD map shows IVB inundated with 1m sea level rise.

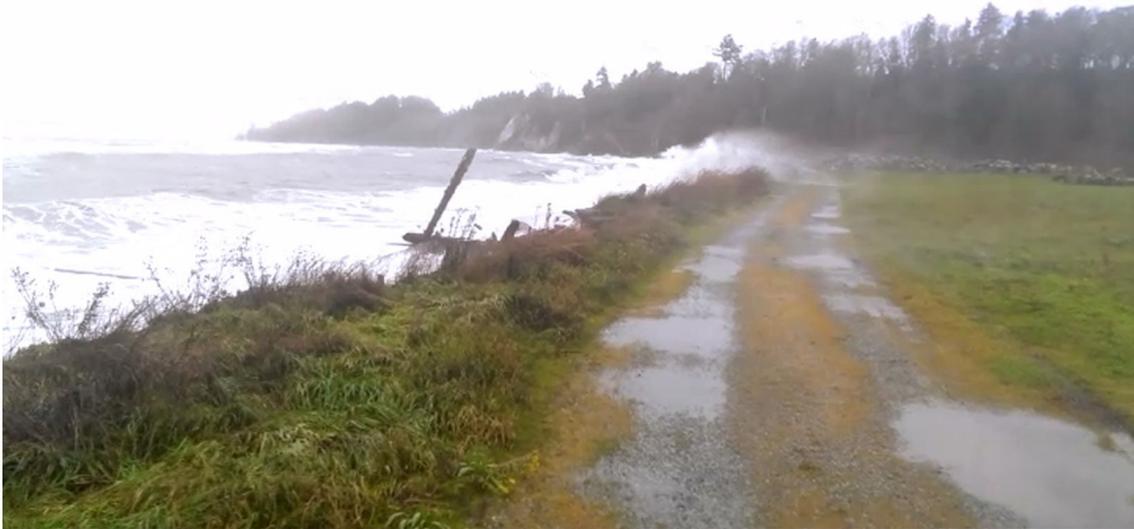
Waves breaking over
the south berm,
December 5, 2015

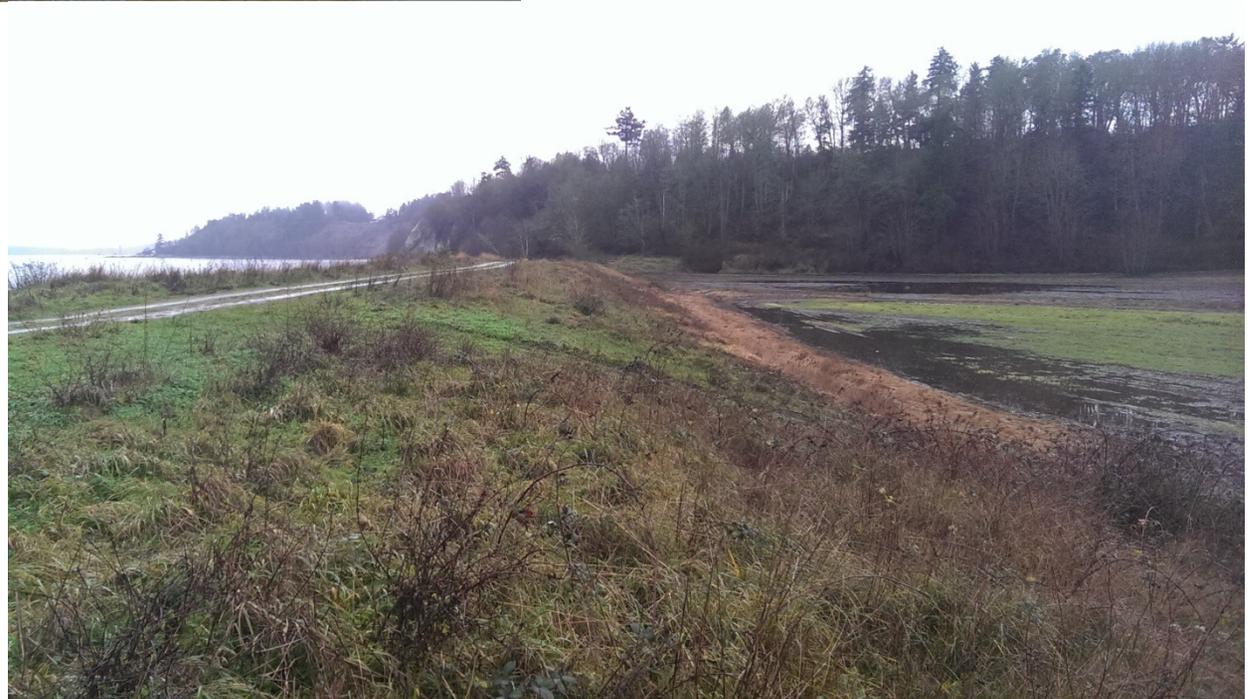
The inland side of
the berm that the
waves were
breaking over

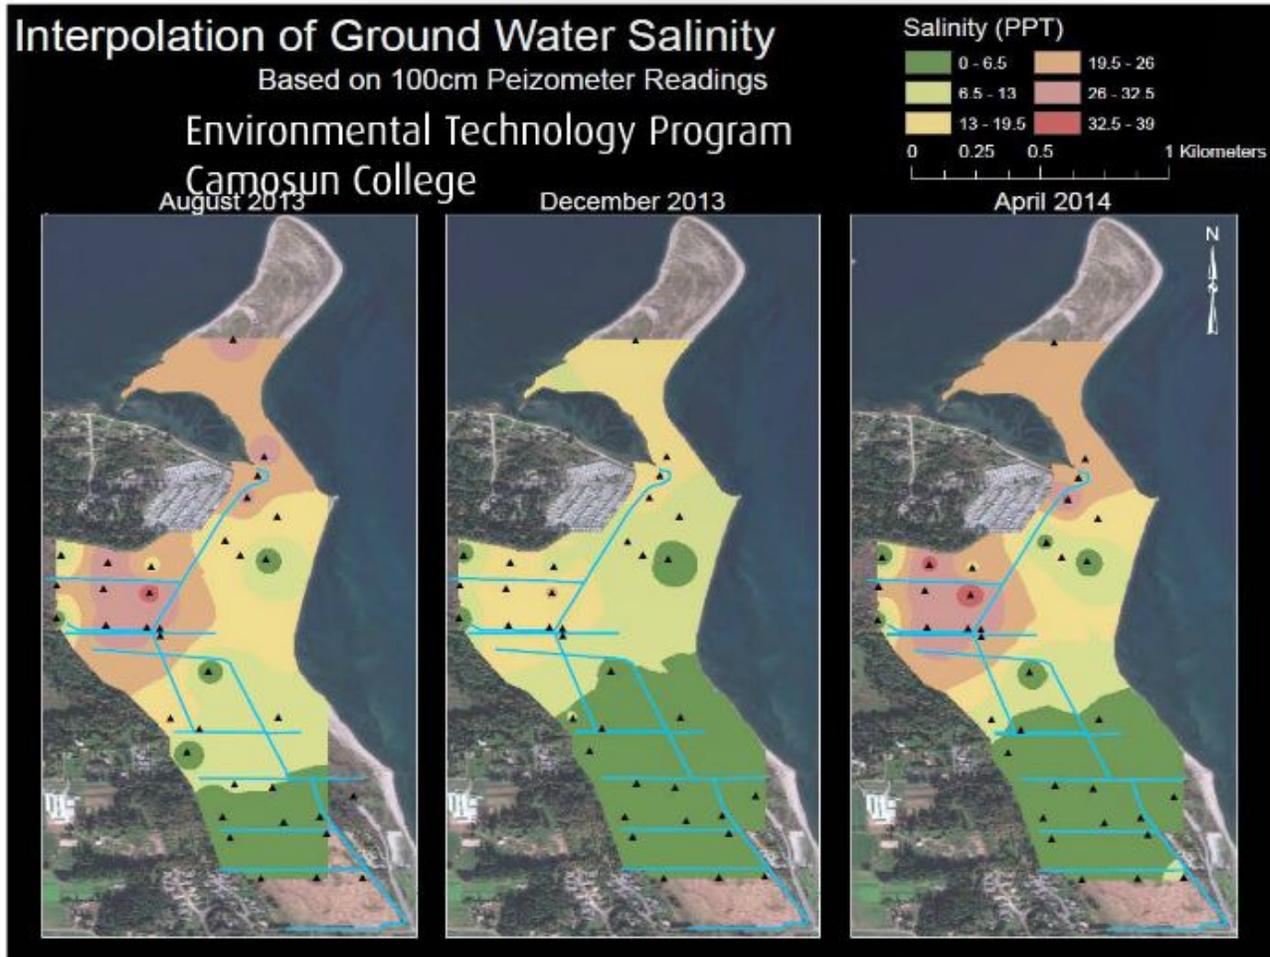
On these maps, the orange and red zones are considered salt¹ water, the yellow and light green would be considered brackish¹ (between salt and fresh) and the darker green would be considered fresh¹ to mildly brackish.

The data show that in late summer and early spring the area is dominated by salt and brackish water. During the peak of the rainy season in December, the influence of freshwater is slightly more, particularly in the southern portion of the study area, but water is predominantly brackish.

The CRD did not disclose that the Tsawout lands, where the highest salinity was reported, have been flooded with salt water from the failed flapper gate for something like 25 years. This man made event is a likely cause of the high salinity found there.

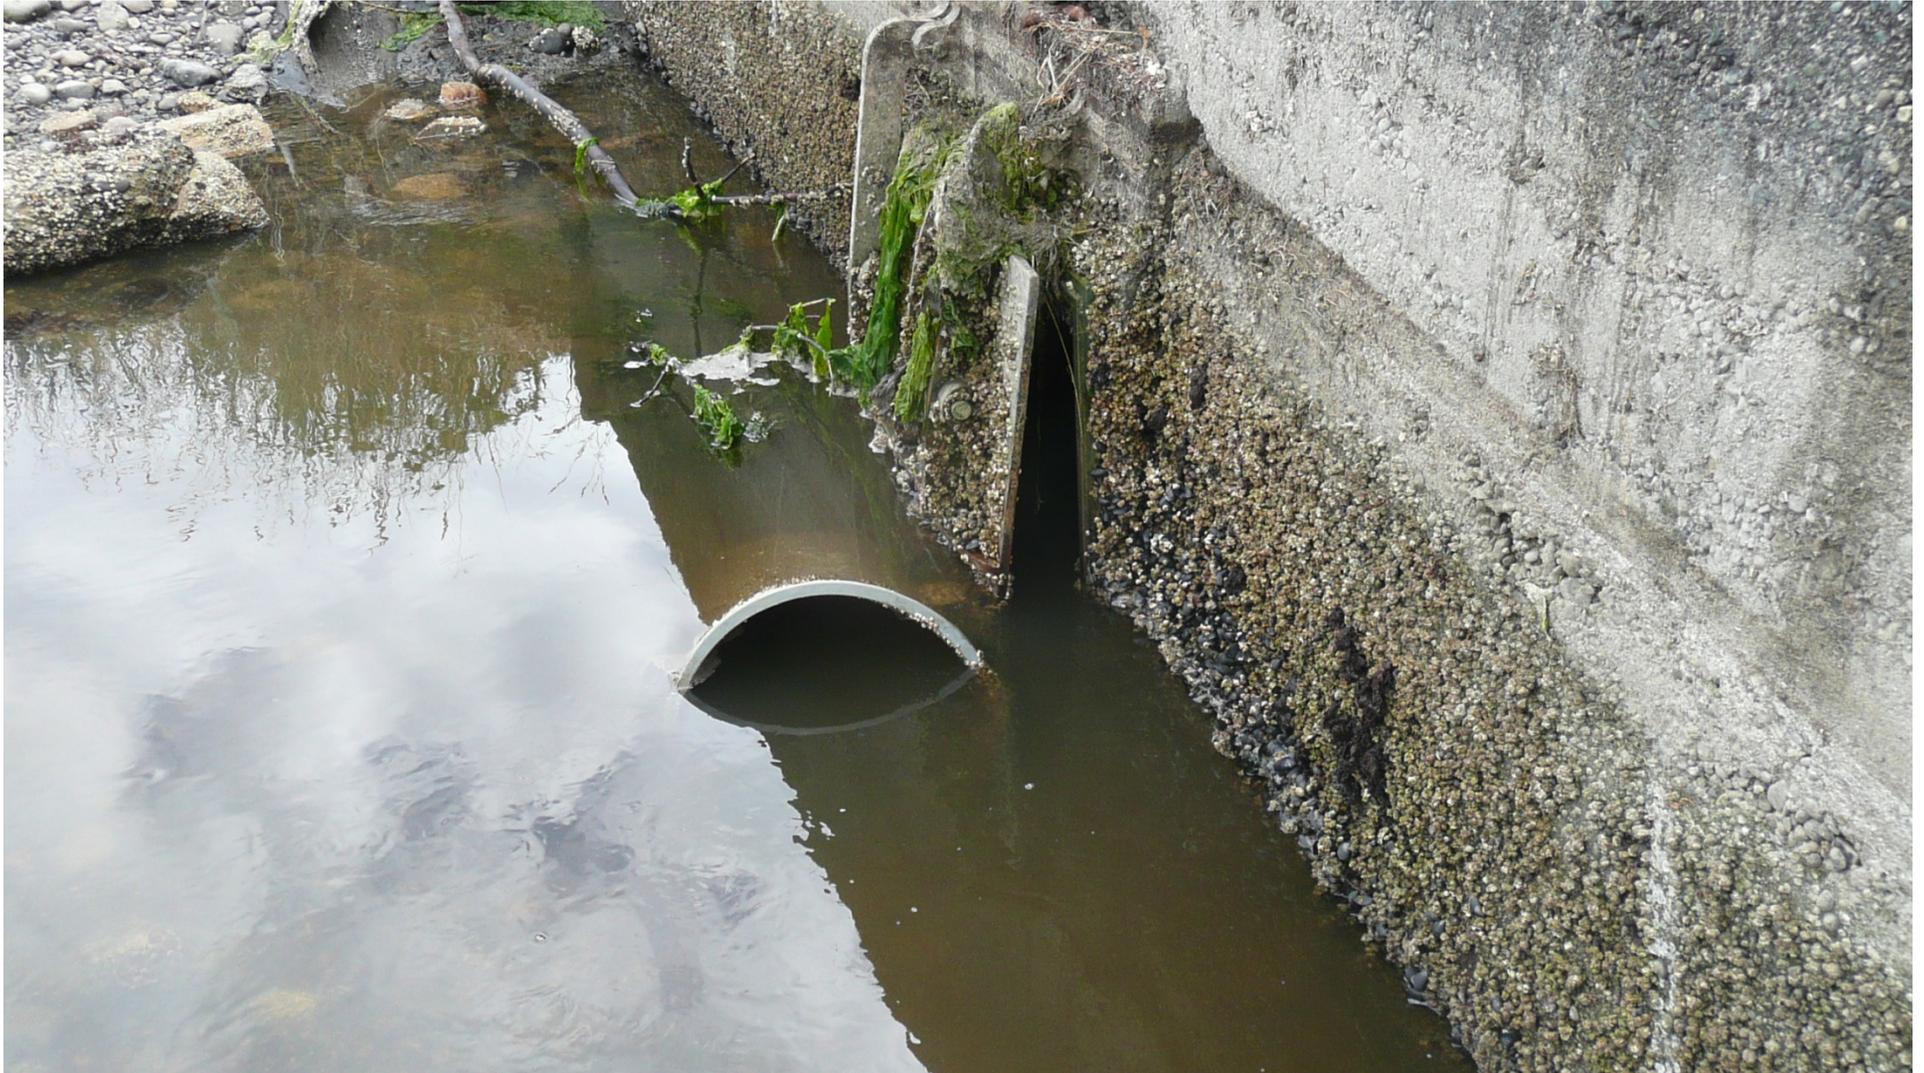
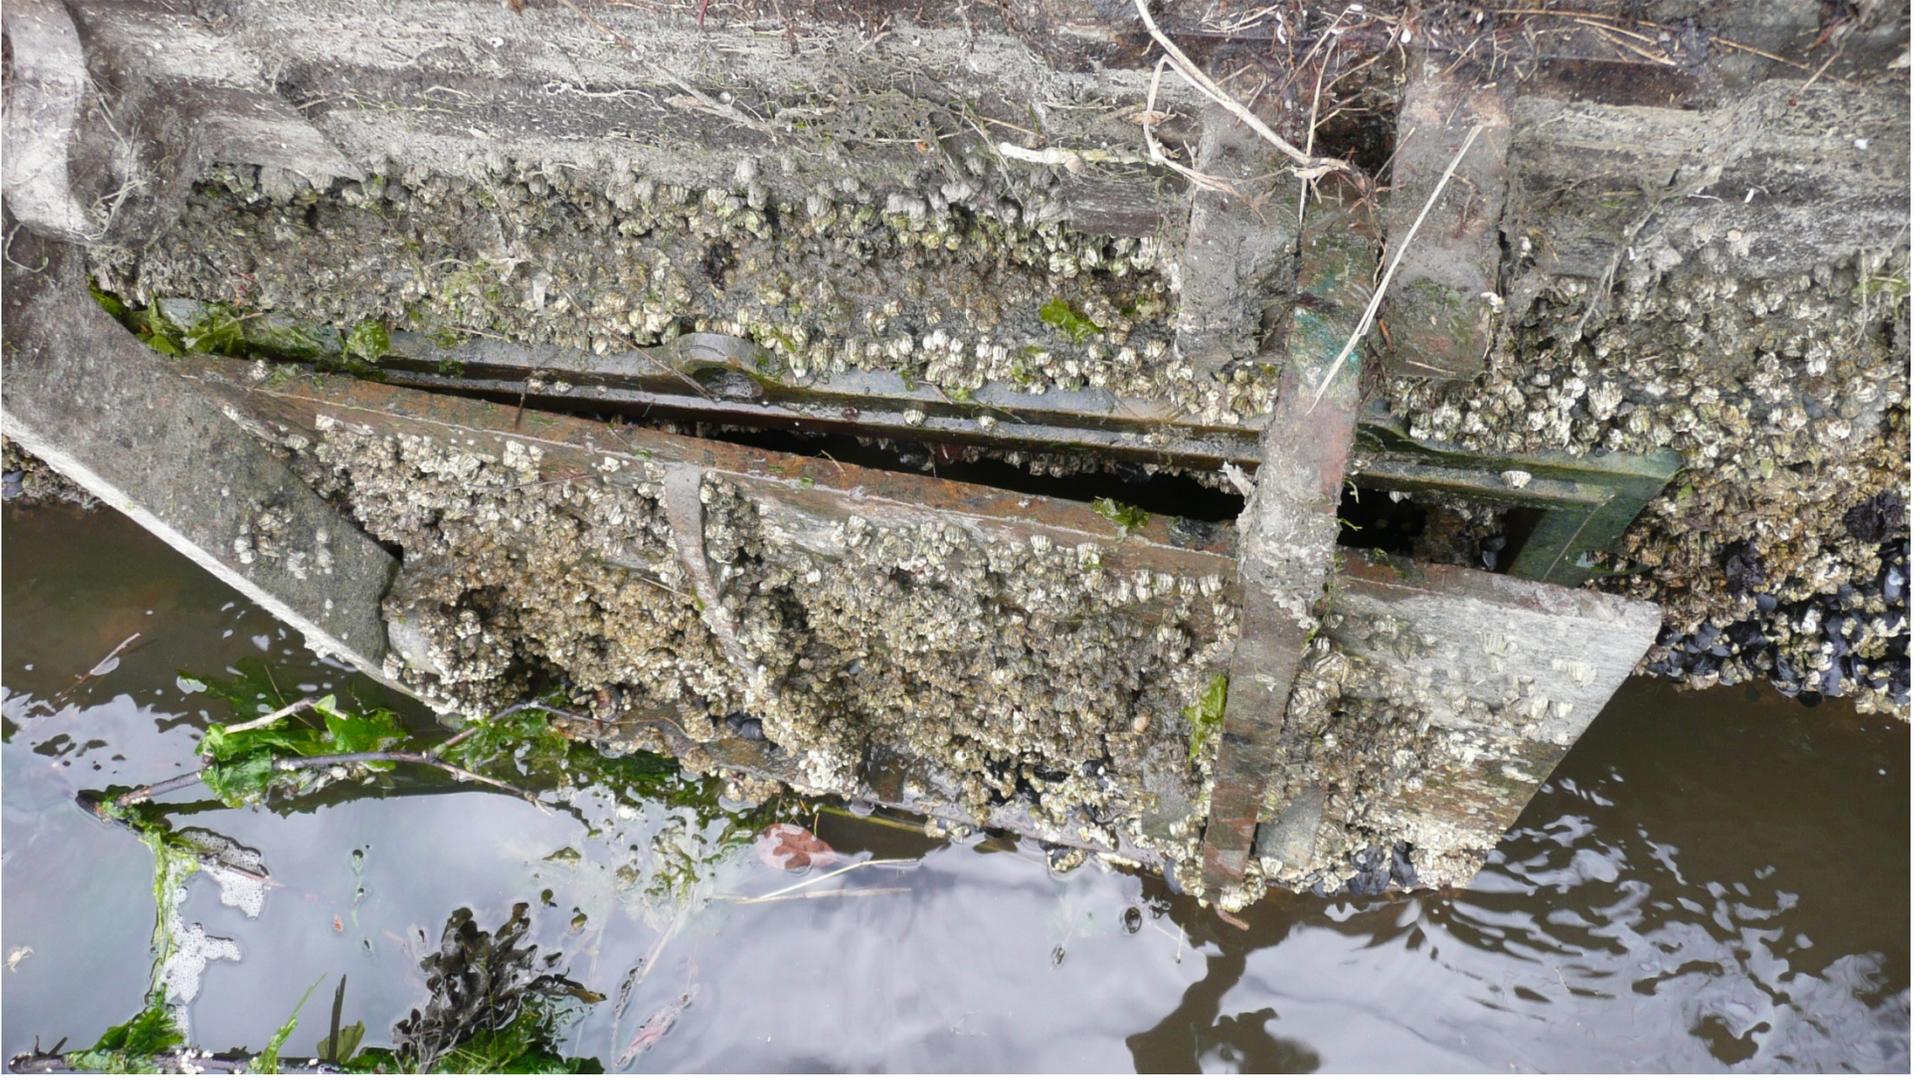
The north drainage flapper gate wide open for 20+ years

During that time the flapper gate in the Tsawout drainage system was wide open and allowed salt water to flow freely up the Tsawout ditch and tidally flood the interior lands of the Tsawout flatlands, Puckle Farm and the CRD park with salt water.

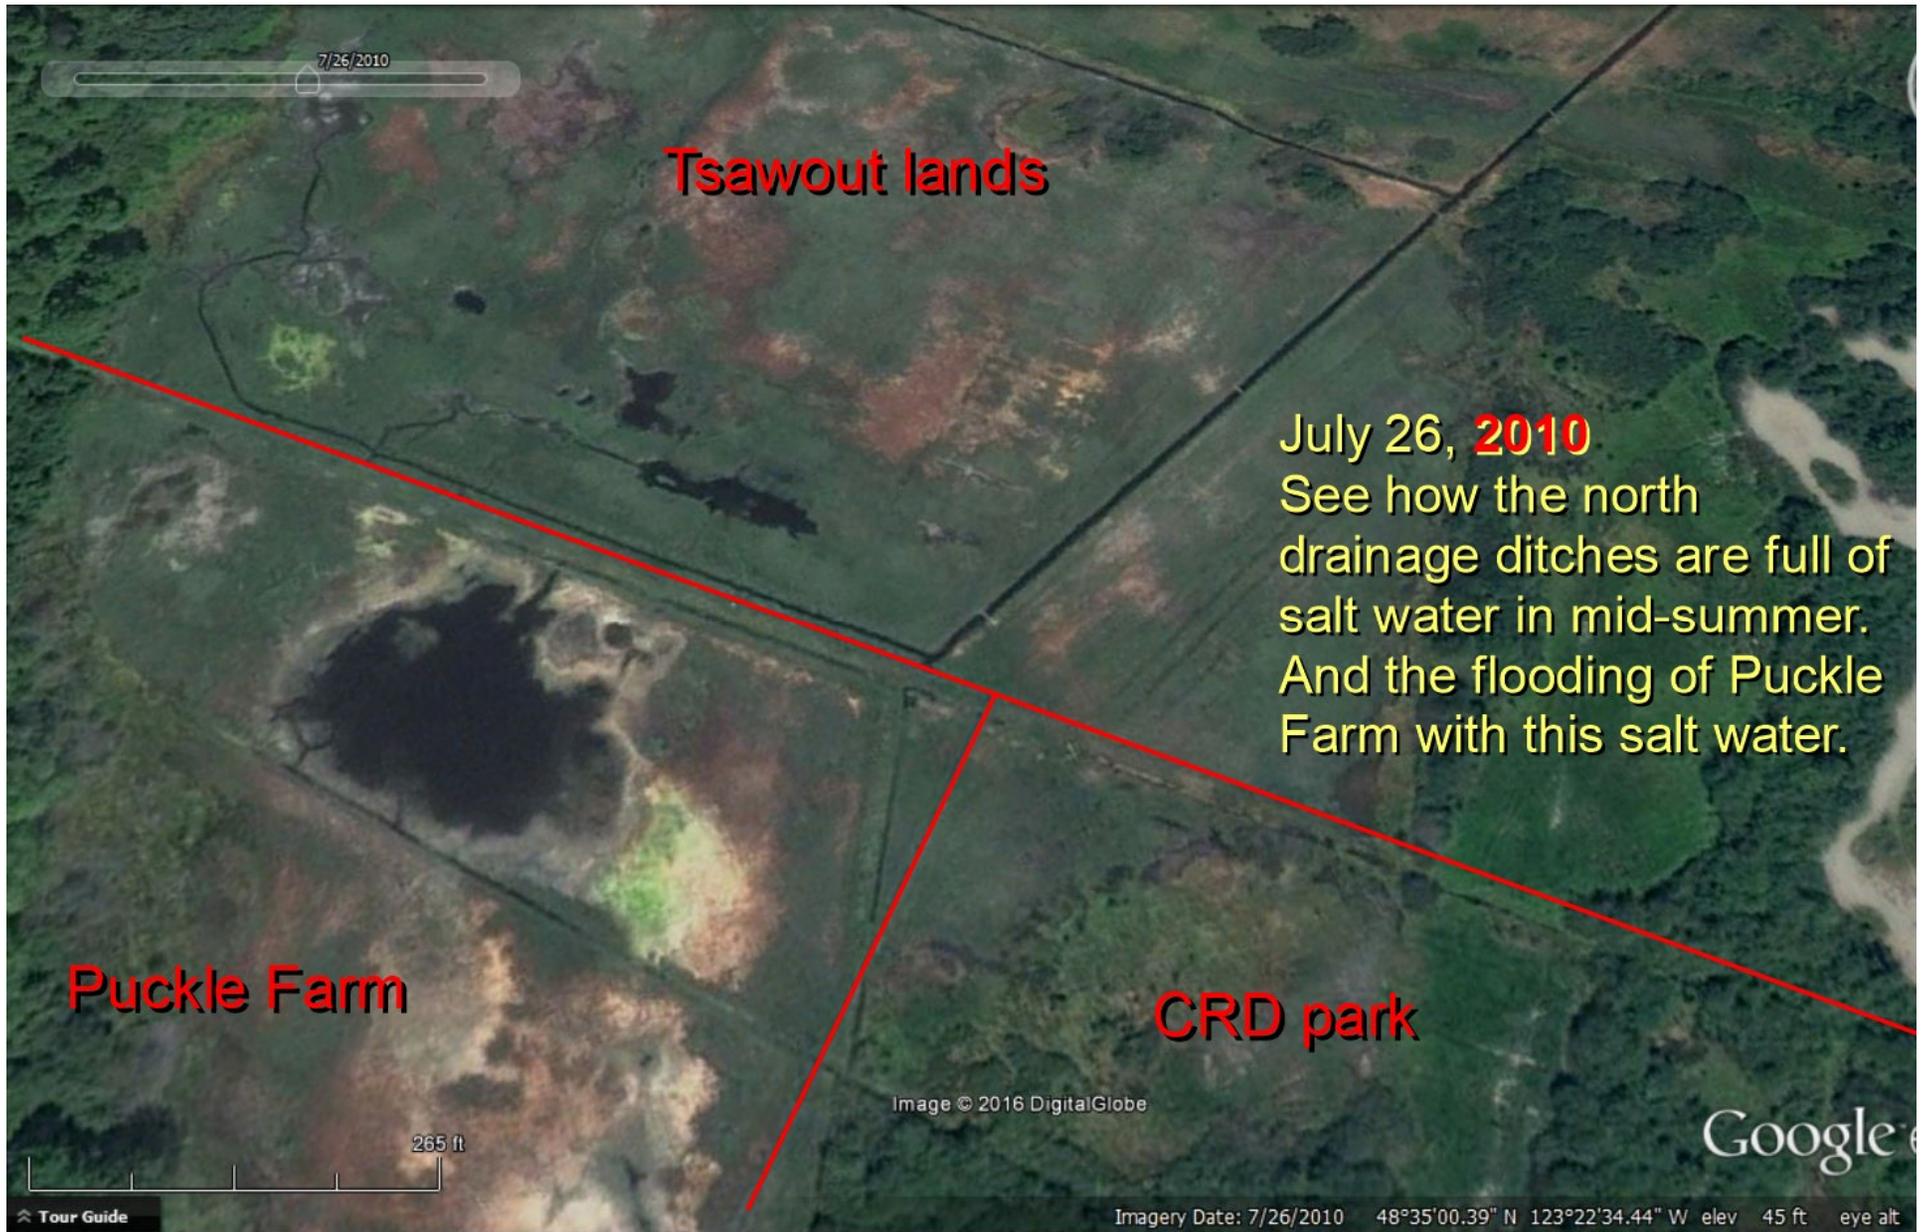
Salt water flooding caused by the failed flapper gate

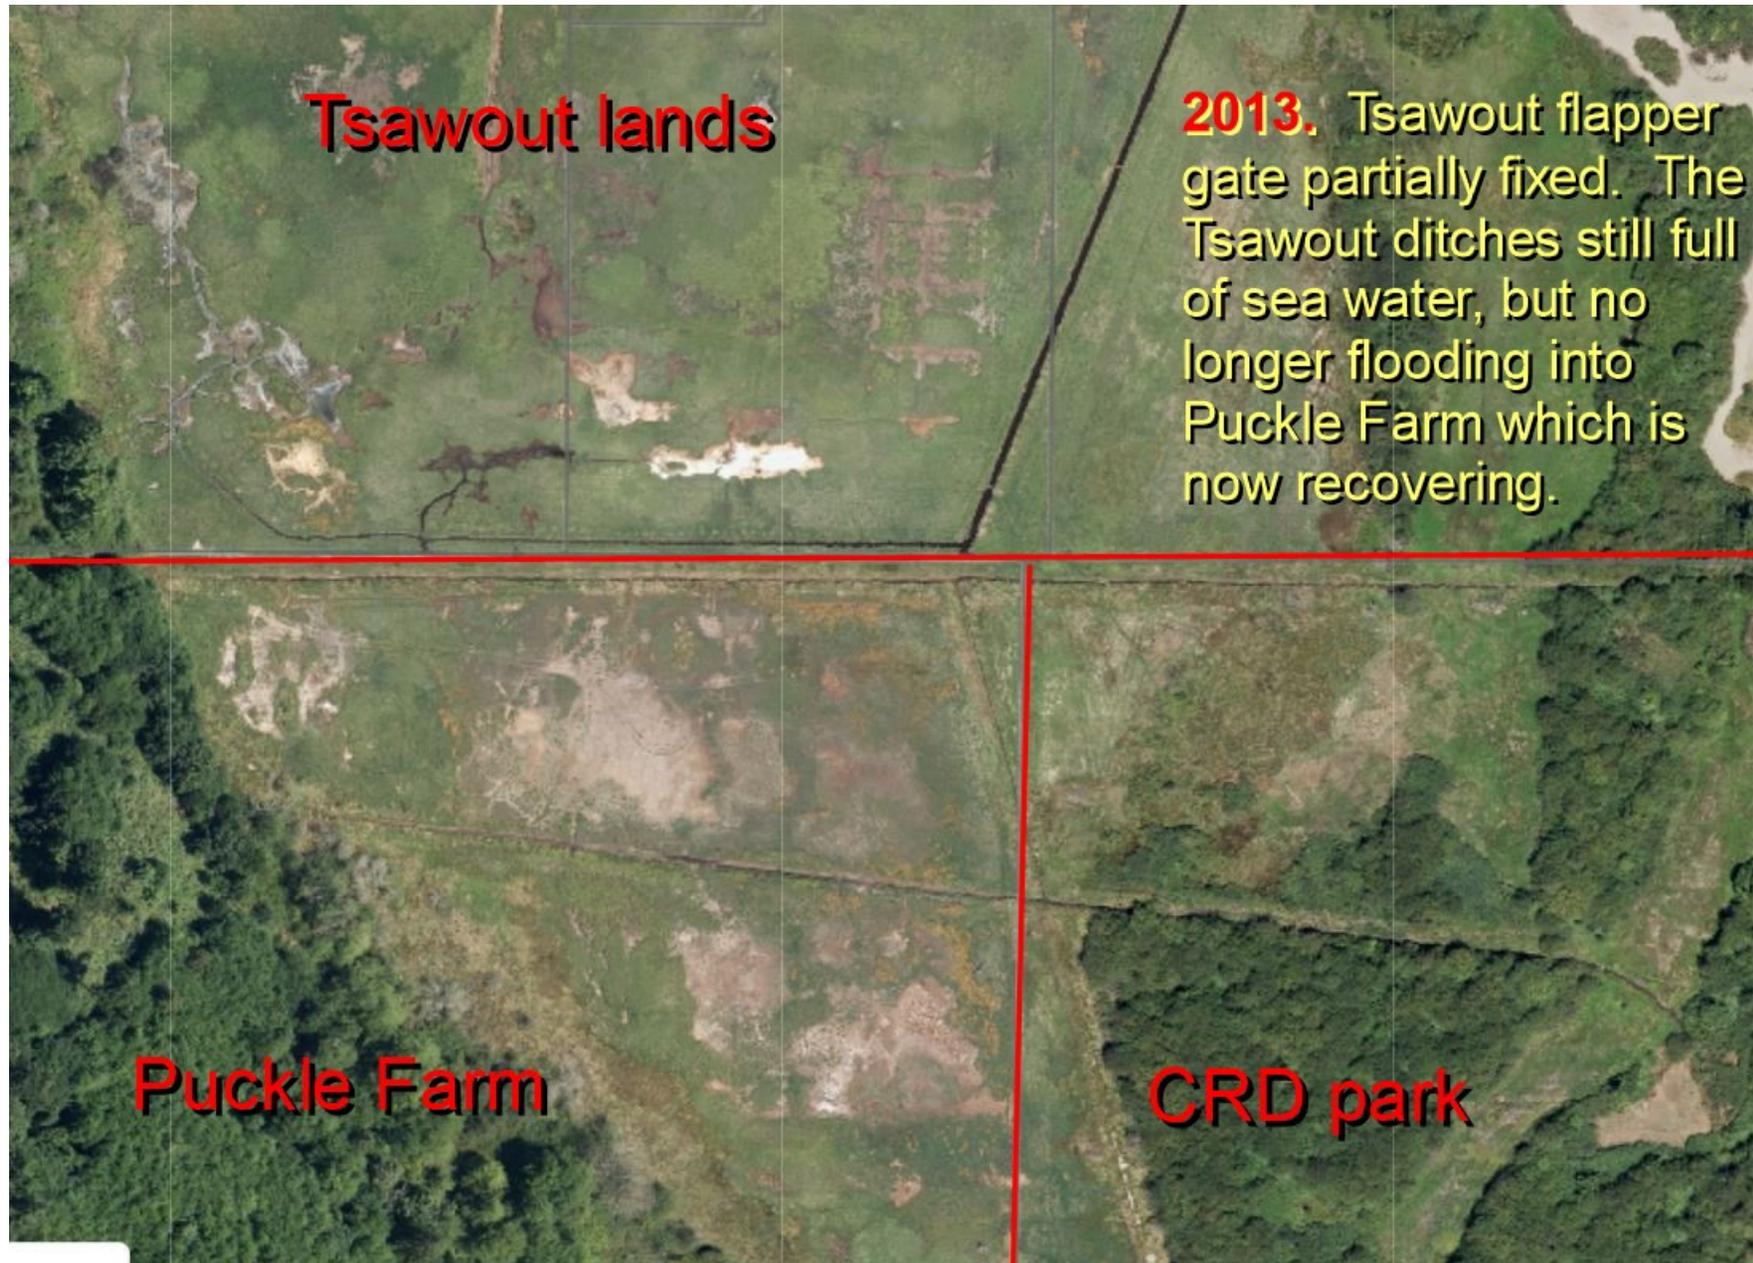
The land after the flapper gate was partially fixed.

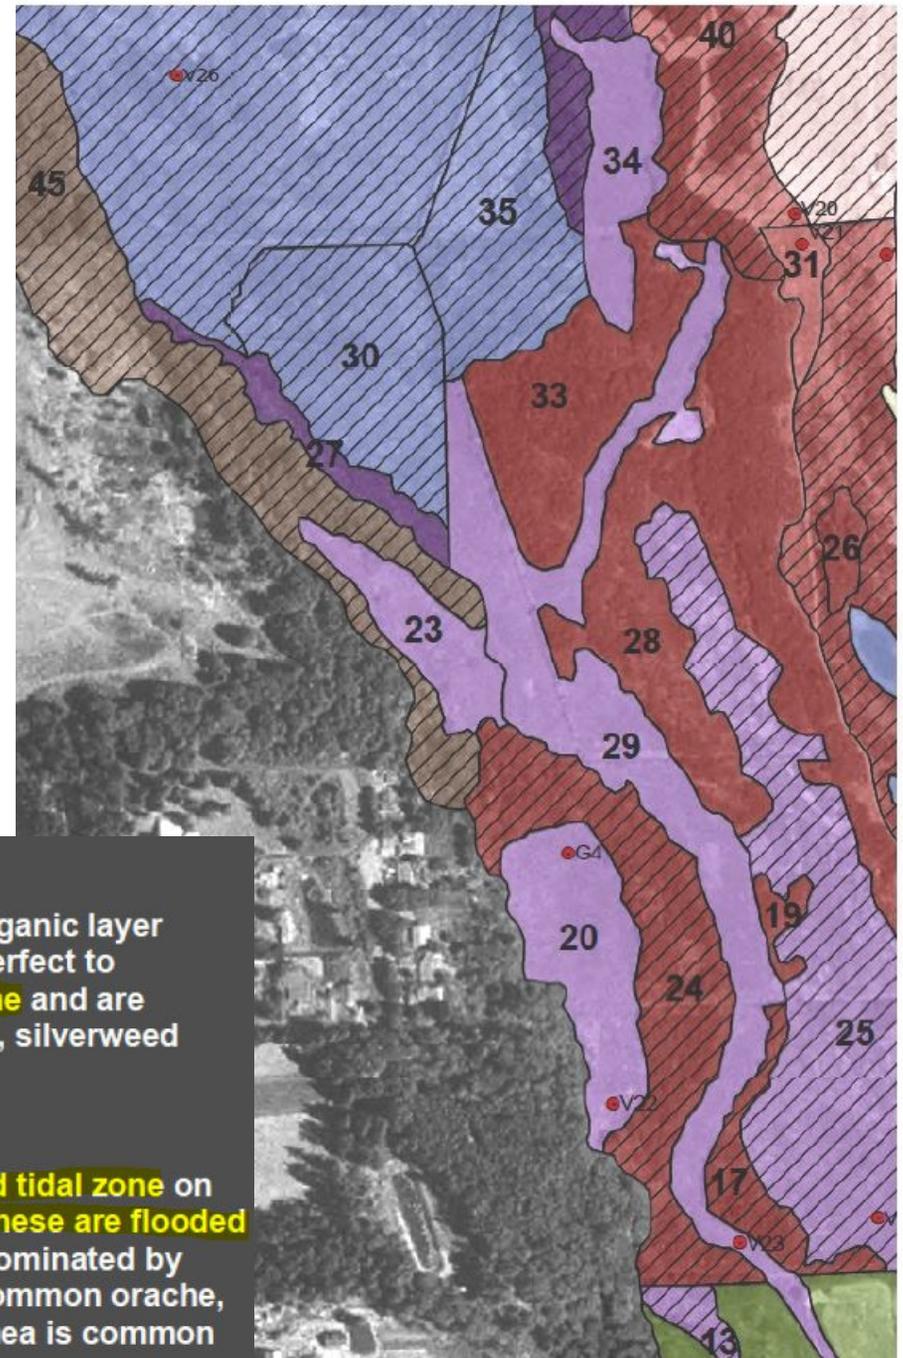
The flawed 2009 TEM report showing much of the west side of the CRD park to be either **high intertidal zone**, or **tidal zone** that is “flooded daily for long periods”

There is no natural tidal action on this land. What the TEM authors saw in 2008 was flooding caused by the failed flapper gate

Estuarine ecosystem occurring on sites with a thin organic layer over sandy marine sediments where drainage is imperfect to very poor. These sites occur in the **high intertidal zone** and are rich and wet. Vegetation is dominated by Arctic rush, silverweed and sea arrow-grass

Estuary ecosystem occurring in the **lowest vegetated tidal zone** on poorly drained, fine sand to silt marine sediments. **These are flooded daily for prolonged periods.** Vegetation is typically dominated by seashore saltgrass but high cover of sea plantain, common orache, coast silverweed, American glasswort or fleshy jaumea is common in the study area.

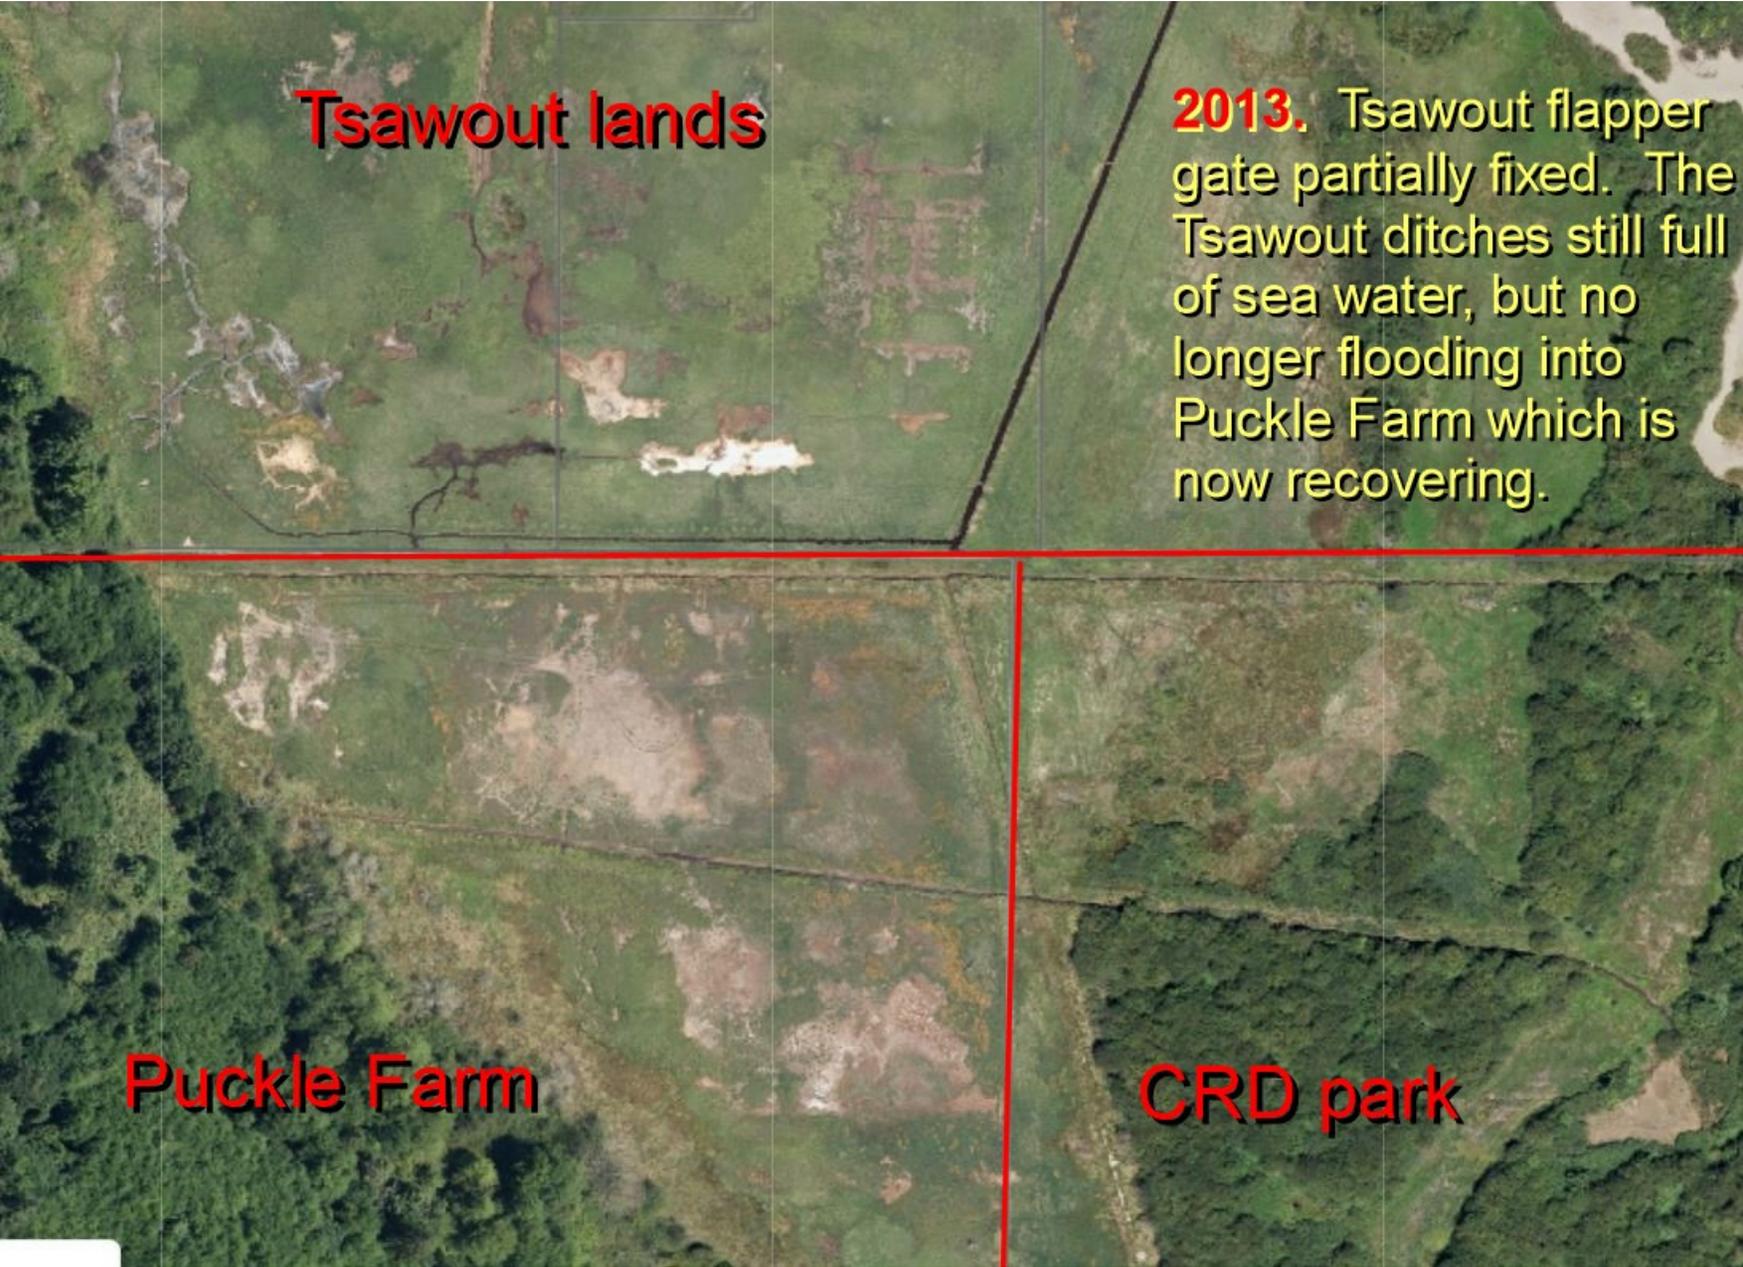
2013. Tsawout flapper gate partially fixed. The Tsawout ditches still full of sea water, but no longer flooding into Puckle Farm which is now recovering.

The flapper gate on the Tsawout drainage ditch failed some 25 years ago, allowing salt water to flow up the ditch and contaminate the environment and change the ecosystem. We call on the CRD to assist the Tsawout to repair or replace this flapper gate so that in time the environment may recover.

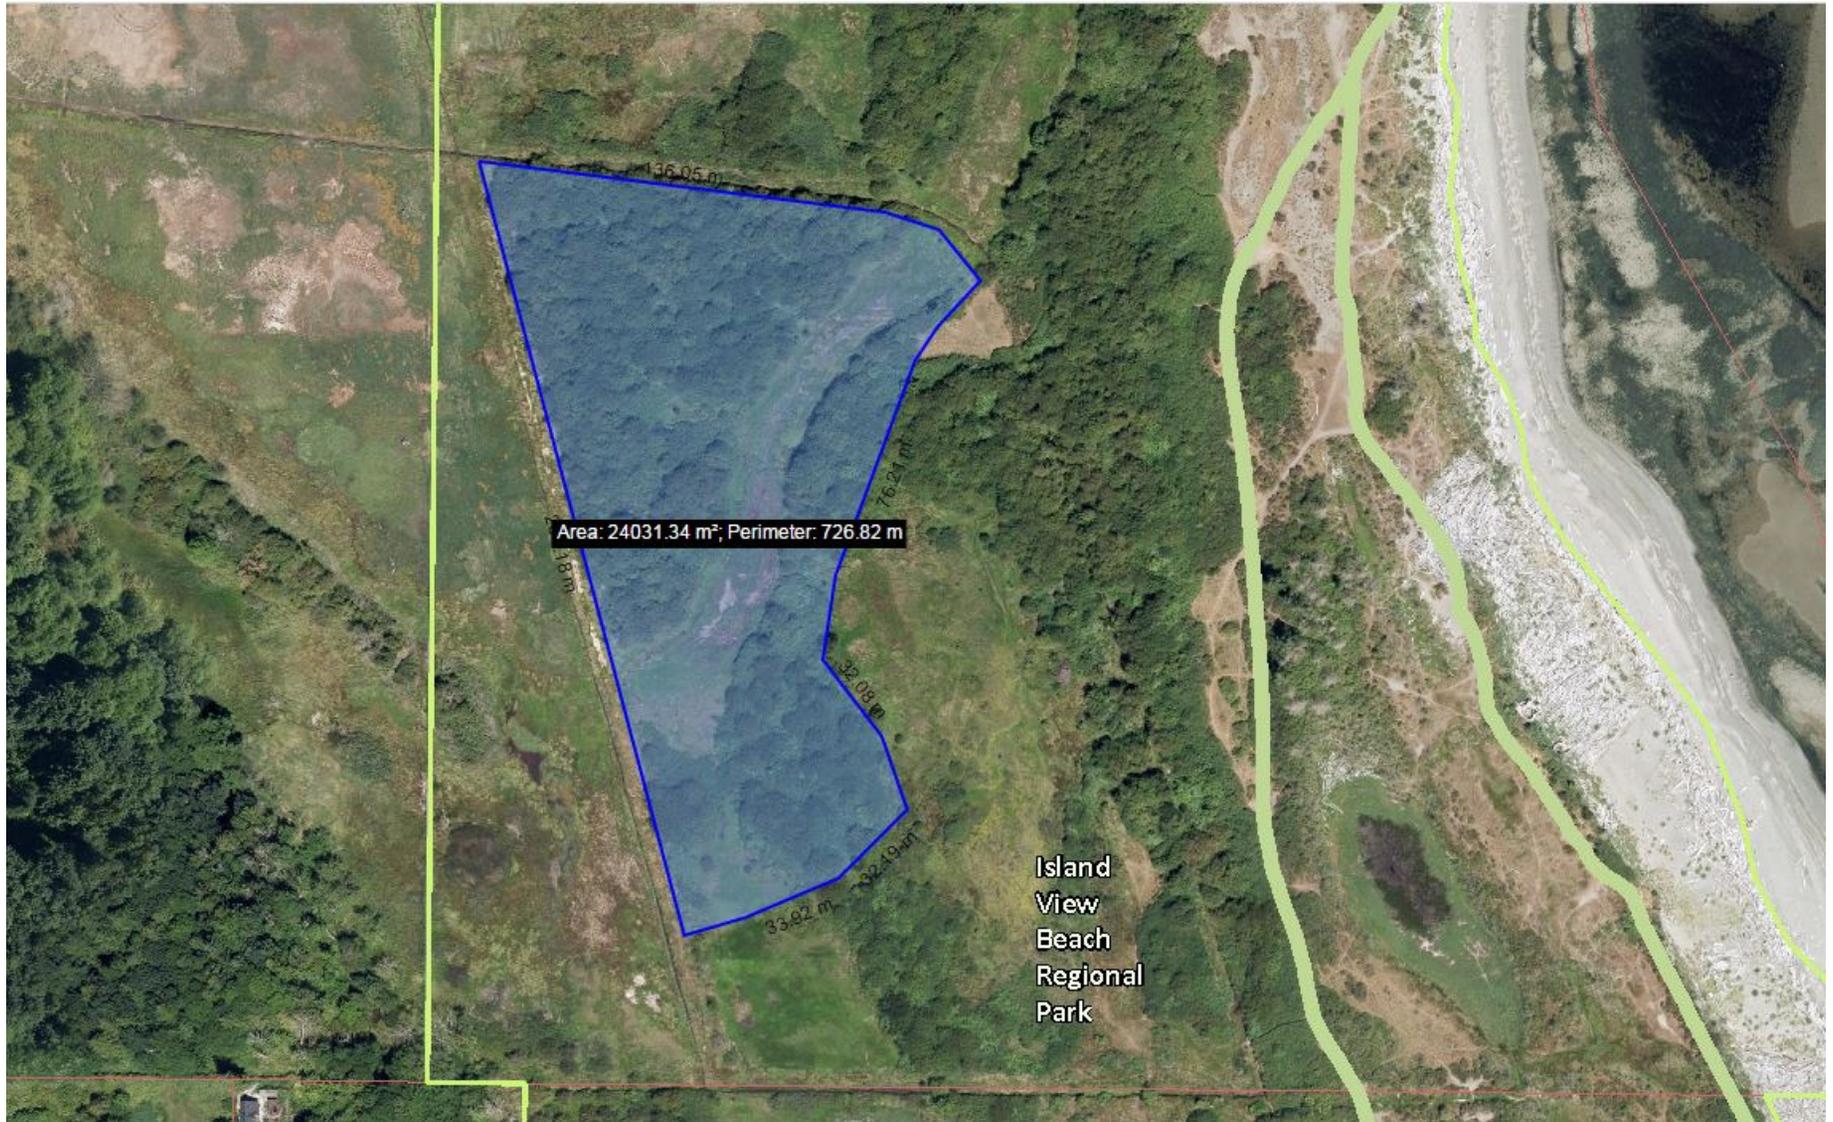
Proposed nature reserve

We note there are 6 acres in the park that are delineated by clear physical characteristics and not readily accessible by the public, that are ideal as a Nature Reserve. This is in the north end of the park, bounded by mosquito drainage ditches on two sides and is encircled by dense brush, with a swampy area running diagonally through it.

With a small amount of fencing at each end of the diagonal swamp area, this Nature Reserve would be totally protected from human activities, and the screen of dense brush it would keep it quiet too.
